KENNEBEC RIVER BASIN
NEWPORT, MAINE

MAIN STREET DAM
ME 00114

PHASE I INSPECTION REPORT
NATIONAL DAM INSPECTION PROGRAM

MAY 1981

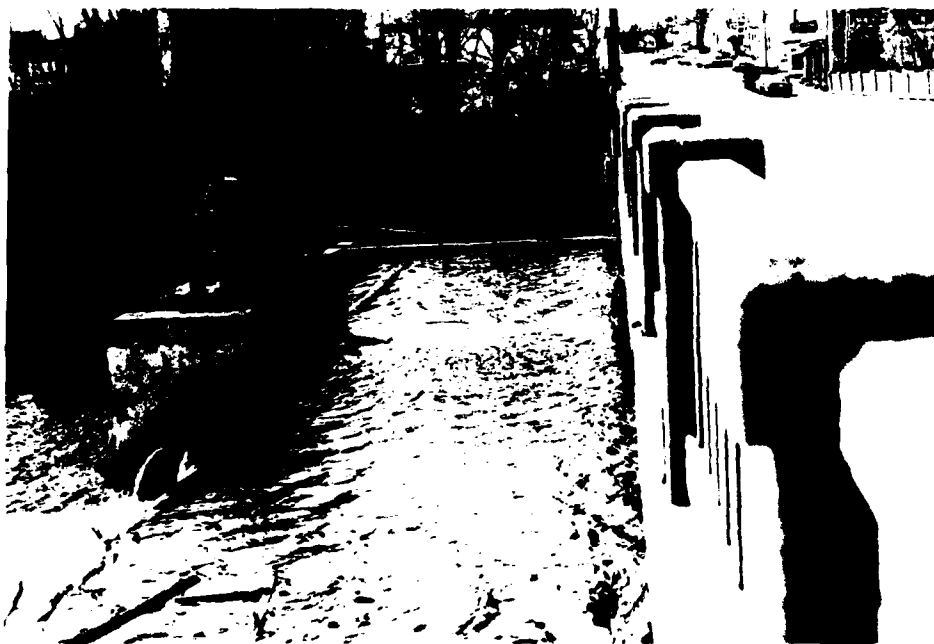
c. Appurtenant Structures. The outlet works located at the right center of the spillway was in fair condition, Photo No. 7. The concrete abutments were generally deteriorated and eroded with some cracking present. Only the center of the three slide gates appeared to be in operable condition. This gate was partially open during the site visit, but, no attempt was made to operate it. The outlet works was accessible from the Main Street Bridge via three loosely placed planks across a steel post truss bridge. The steel portions of this footbridge were moderately rusted. Bolts anchoring the footbridge to the outlet works and the Main Street Bridge appeared in good condition.

The outlet works of Main Street Dam warrants attention to prevent further deterioration. The cracking and erosion of the concrete should be repaired. However, the structural stability of the outlet works appears to be satisfactory at the present time.

7. Alignment of dam and outlet works

1. Repair the eroded, spalled and generally deteriorated concrete of the spillway abutments.
2. Repair the deteriorated and cracked areas of the concrete portions of the outlet works and maintain at least one slide gate in good operating condition.
3. Remove the loosely placed wood planks across the outlet works access bridge and install a permanent, stable walkway. The steel portions of the bridge should be painted periodically to inhibit rust and deterioration of the bridge.
4. Periodically remove the debris from the upstream side of the dam, particularly in the vicinity of the spillway.
5. Prepare an operations and maintenance manual for the dam. The manual should include provisions for annual technical inspection of the dam and for round-the-clock surveillance of the dam during periods of heavy precipitation and high project

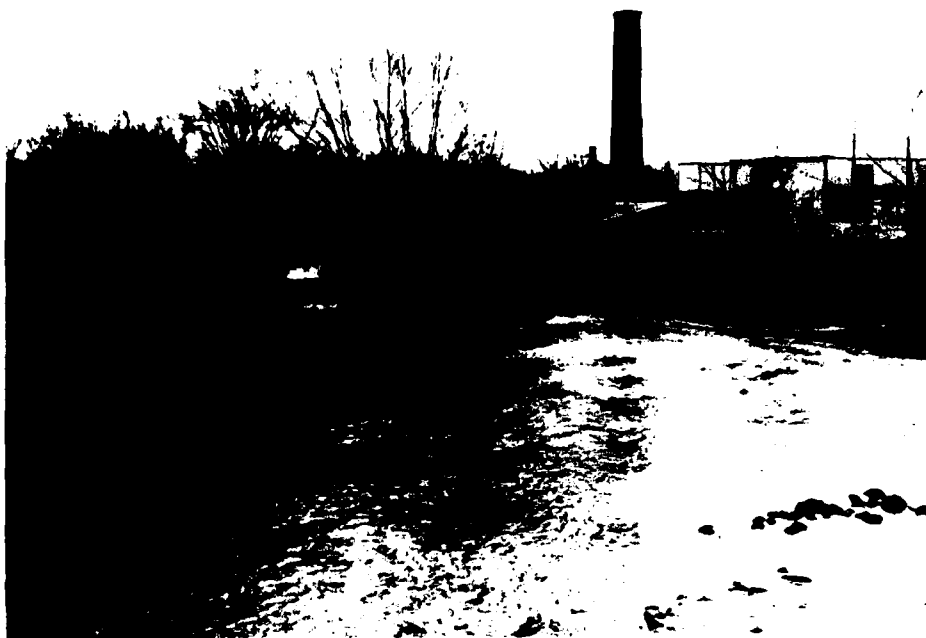
15. River channel immediately downstream of spillway from left abutment
